NASA Technical Memorandum 83786

Fracture Surface Characteristics of Notched Angleplied Graphite/Epoxy Composites

Carol A. Ginty and Thomas B. Irvine
Lewis Research Center
Cleveland, Ohio

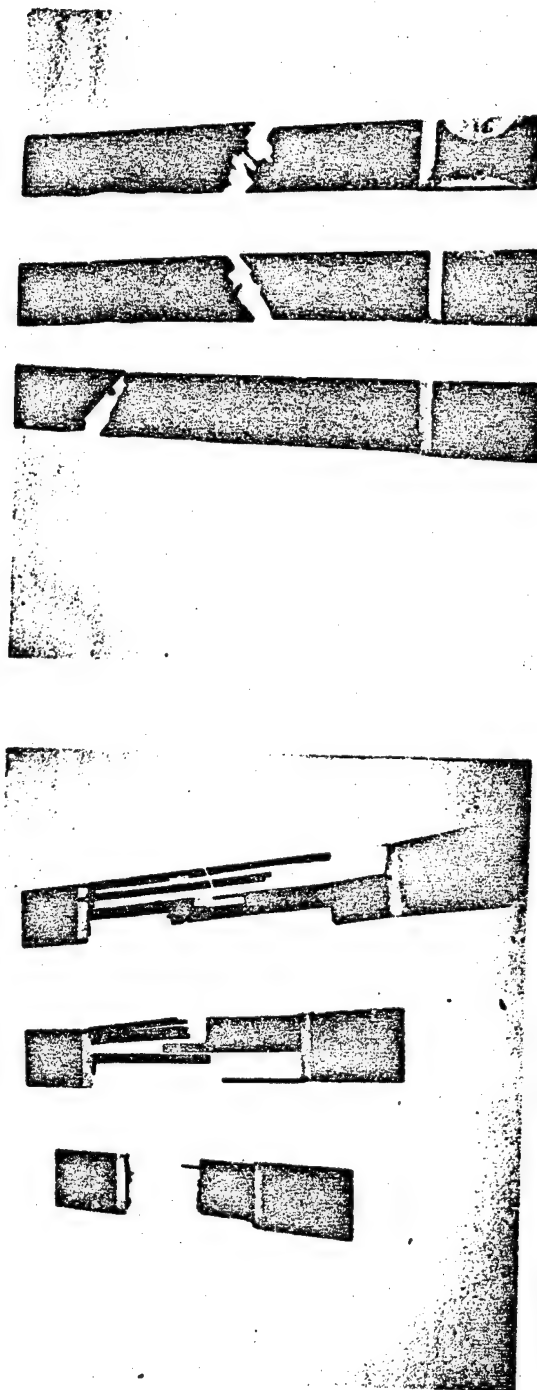
Uniaxial tension testing of the specimens was conducted in an incremental load-to-fracture manner using a 50 kip load frame with a prescribed load increment size. Fracture was catastrophic for the lower angle (0° to 15°) G/E specimens leaving very little of the composite intact (fig. 1(a)). The remaining angleplied specimens (30° to 90°) exhibited a brittle fracture process that produced puzzle-like pieces of the composite as the specimens broke apart (fig. 1(b)). Table I lists the fracture loads of the solid and notched specimens for each laminate configuration in the series.

Figure 1. - Fractured G/E specimens from left to right -- solid, notch/slit and notch/hole.

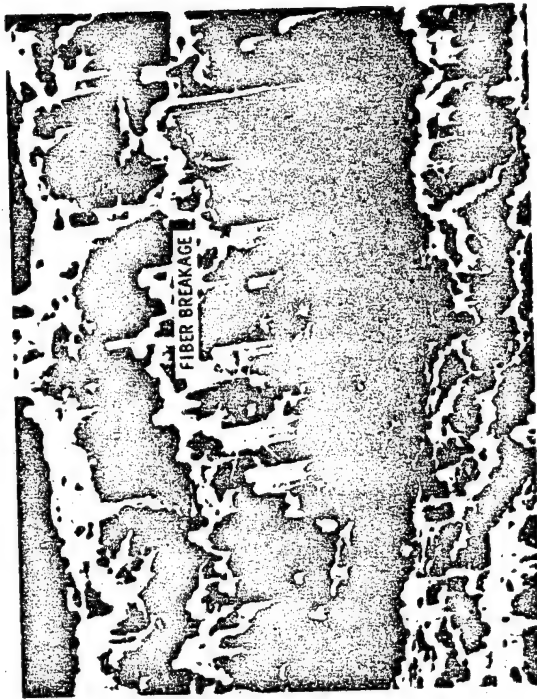
(b) 240X

At greater magnifications (figs. 2(b) and (c)) a characteristic associated with an intraply shear mode is observed. This characteristic is represented by the presence of matrix debris being squeezed out between the fibers. This characteristic is referred to here as matrix hackles. The amount of matrix hackles present is minimal indicating that even though a shearing mode did exist, its contribution to final fracture was minimal and that the primary mode of fracture for this unidirectional laminate was a longitudinal tensile mode.

Figure 2 - Microstructural fracture surface characteristics of a notch/slit unidirectional G/E laminate. The dominant characteristics are the tiered and pulled-out fibers.

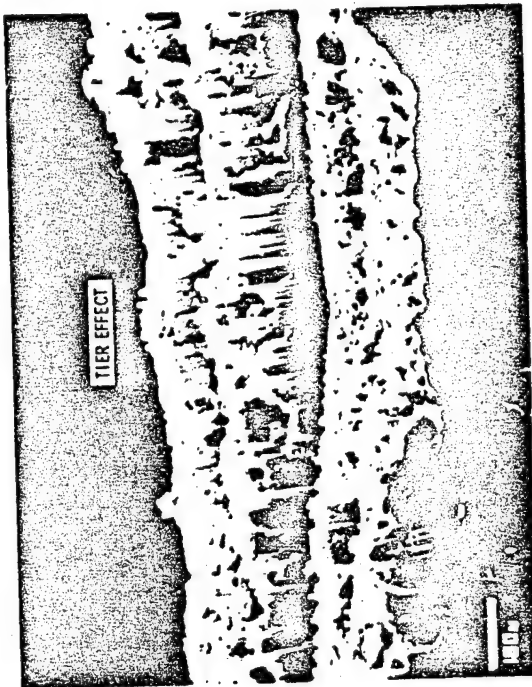
(a) 120X

The fracture surface characteristics of the notched G/E unidirectional laminate are presented in figure 2. The distinguishing feature of the fracture surface is the tiered fibers (ref. 2) as seen in figure 2(a). This tiered effect is the result of fiber pull-out caused by fibers breaking at various locations along the length of the fiber. Note that the fiber surfaces in figure 2(c) are relatively clean and free of matrix residue. This unidirectional laminate being tested in longitudinal tension will fracture due to a longitudinal tensile mode. Therefore, the microstructural characteristics just described are indicative of a longitudinal tensile fracture mode with the tiered surface being the primary microscopic feature.

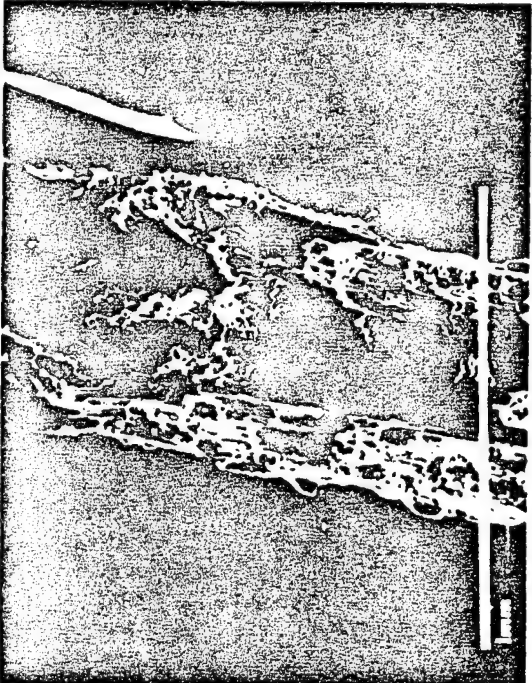
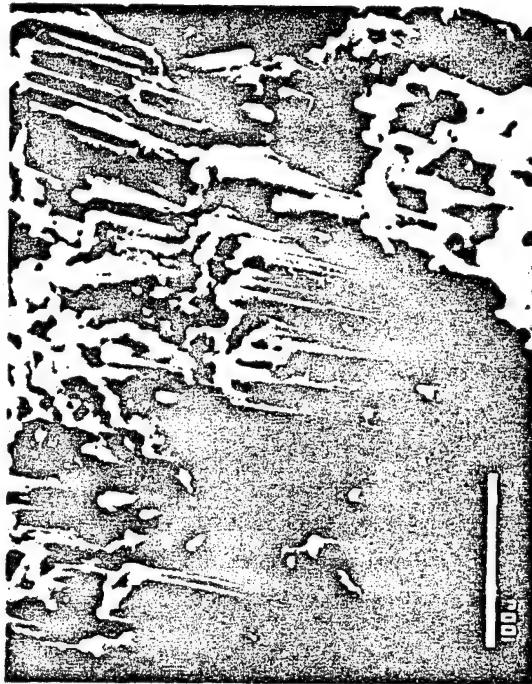
The same microstructural characteristics depicted for the unidirectional laminate are observed on the fracture surface of the $[\pm 3]_s$ laminate (fig. 3). Although the characteristics are similar, there is a distinct change in the tier formation. Figures 3(a) and (b) show fiber pull-out and breakage occurring more randomly. This action still produces an irregular fracture surface but without the wall-like formation of each ply that existed for the unidirectional laminate. In figure 3(c), matrix hackles are apparent indicating an intraply shearing action. Nevertheless, final fracture was the result primarily of a longitudinal tensile fracture mode.

Figure 3. - Photomicrographs of the $[\pm 3]_s$ G/E laminate fracture surface. The predominant characteristic is the fiber breakage.

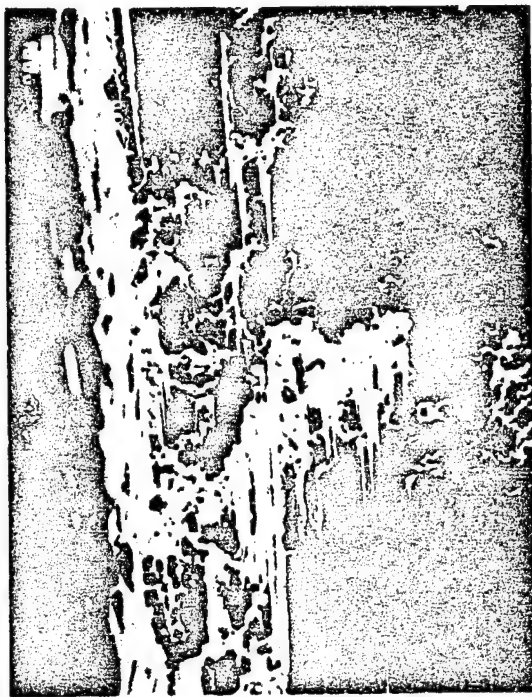
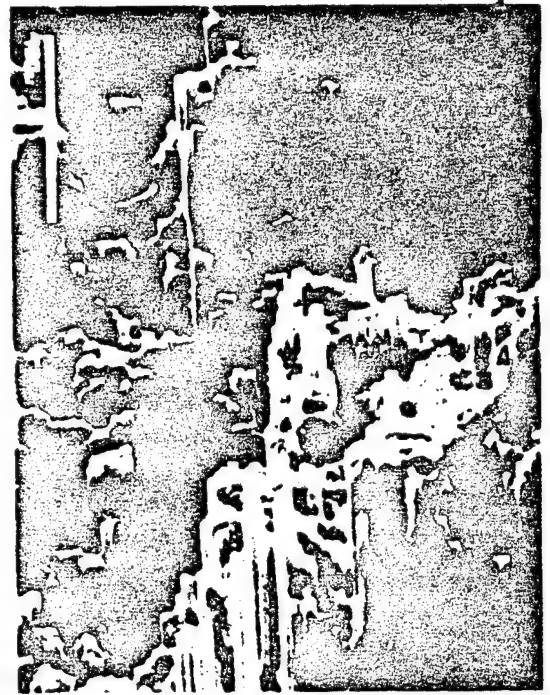
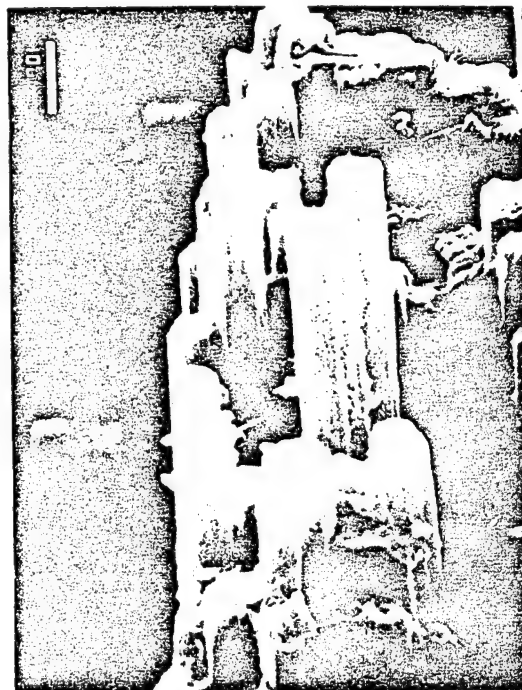
Fiber pull-out and breakage is the dominant trait of the $[\pm 5]_s$ fracture surface displayed in figure 4. Although the surface is still irregular, individual fibers appear to be breaking at the same locations along the fiber resulting in a leveling-off effect. Matrix hackles are more evident suggesting that even though longitudinal tension is still the primary mode of fracture, intralaminar shear is becoming a larger contributor to final fracture.

Figure 4. - Microstructure of the fracture surface of the $[\pm 5]_s$ G/E laminate revealing fiber breakage accompanied by matrix hackles.

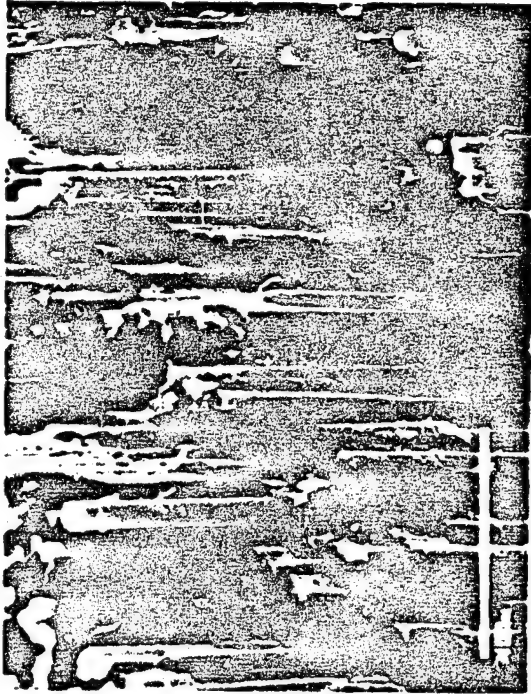
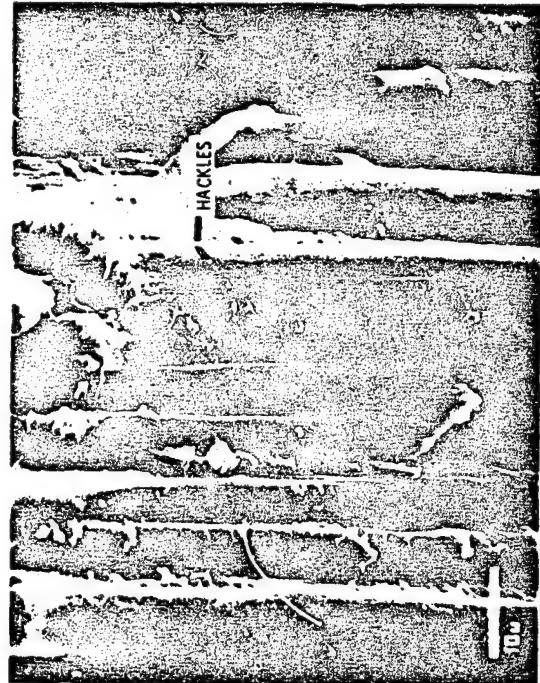
Irregular fracture surface and fiber pull-out are still the outstanding microstructural characteristics for the $[\pm 10]_s$ laminate exhibited in figure 5(a). The photomicrograph in figure 5(b), however, reveals a cluster of fibers with relatively clean surfaces breaking at approximately the same place indicating a combination of longitudinal tensile and intraply shear modes respectively. Figures 5(b) and (c) show matrix hackles appearing in an established pattern between the fibers instead of the random occurrence which was previously observed.

Figure 5. - The fracture surface of the notch/slit ($\pm 10^\circ$)s GE laminate revealing matrix hackles between the fibers.

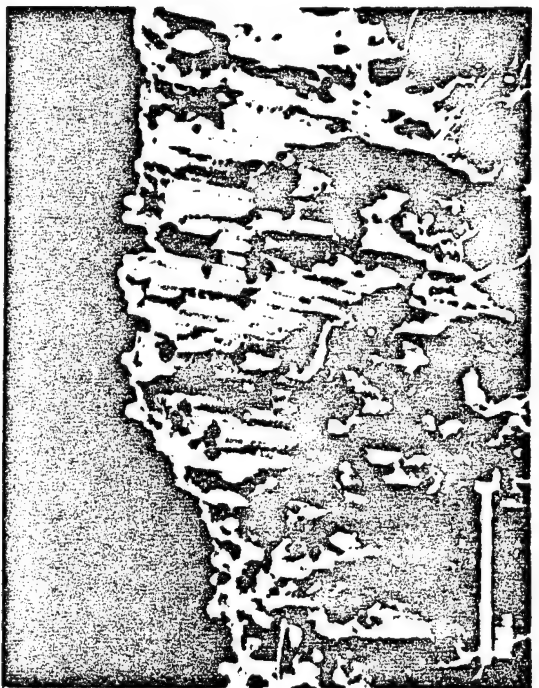
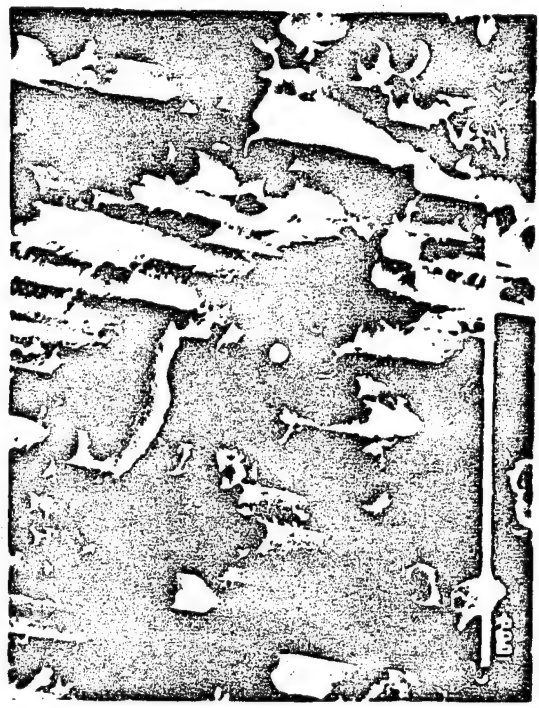
Photomicrographs of the $[\pm 15]_s$ laminate fracture surface are presented in figure 6. The irregular surface (fig. 6(a)) and the clean fibers along with the fiber pull-out (fig. 6(b)) indicate a longitudinal tensile fracture mode. Figure 6(c) reveals not only an abundance of matrix hackles but also matrix debris on the surfaces of the fibers which are now forming a level surface, indicative of an intraply shear fracture mode.

Figure 6. - Photomicrographs revealing the microstructure of the [±15]s GIE fracture surface. Longitudinal tensile and intraply shear fracture modes are characterized by the fiber fracture and matrix hackles respectively.

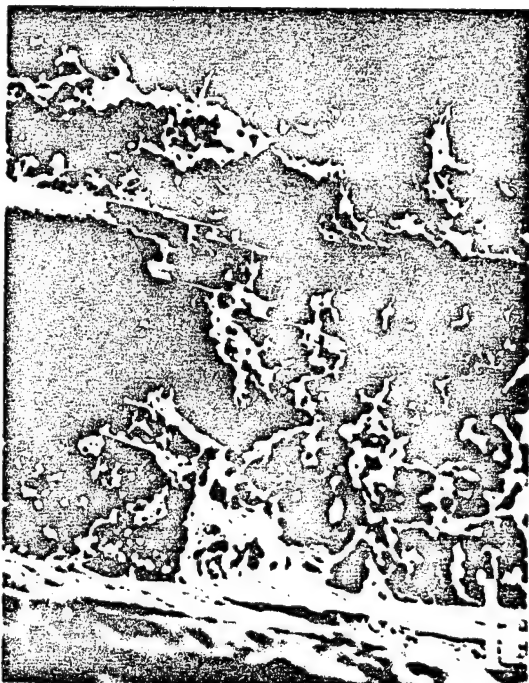
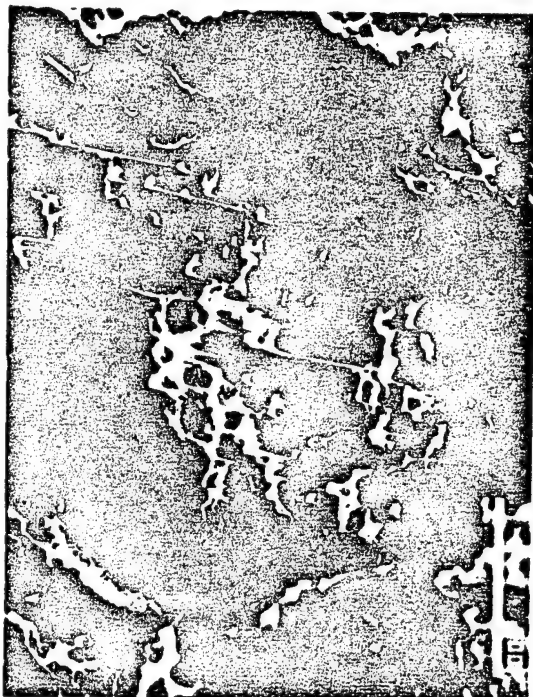
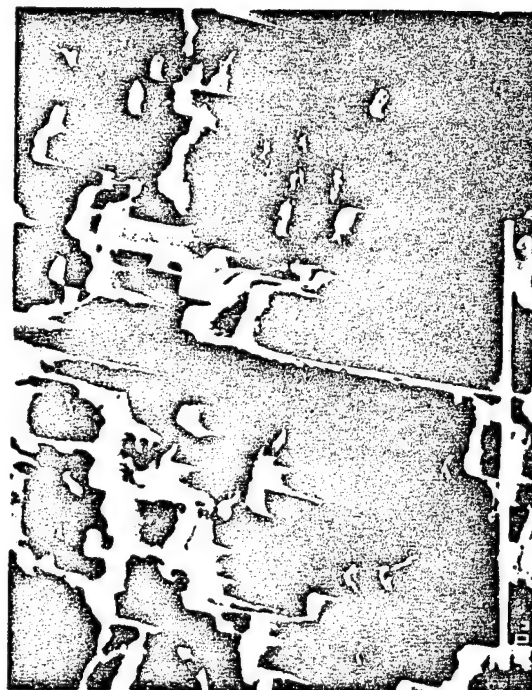
A significant change in the microstructure of the fracture surface is observed in the photomicrographs of the $[\pm 30]_5$ laminate in figure 7. Fibers in the outer plies (+30) are breaking at approximately the same place producing a level surface while the inner plies (-30) are still experiencing fiber pull-out and breakage in different locations. The number of fibers affected by this longitudinal tensile fracture mode is decreasing (fig. 7(b)). At the same time, with the presence of matrix hackles and debris increasing (fig. 7(c)), it appears as though intraply shear is becoming the dominant mode of fracture as the ply angle orientation increases.

Figure 7. - Fracture surface characteristics of the $[\pm 30]_s$ notch/slit G/E specimen. The fibers broke at or near the same place producing a more level surface.

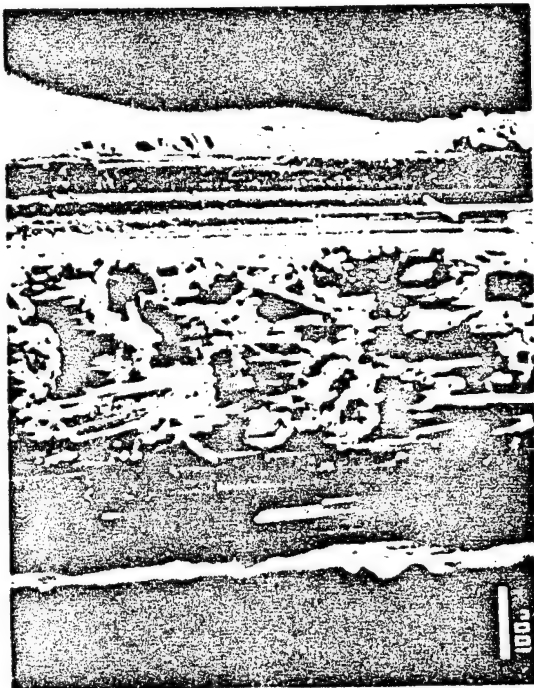
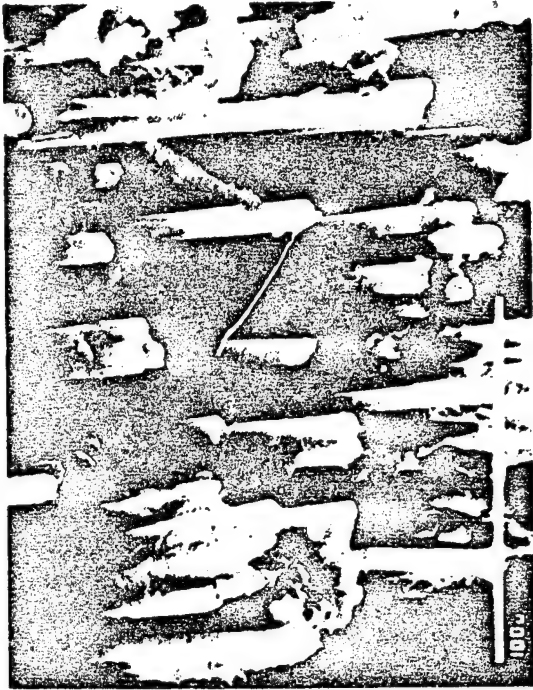
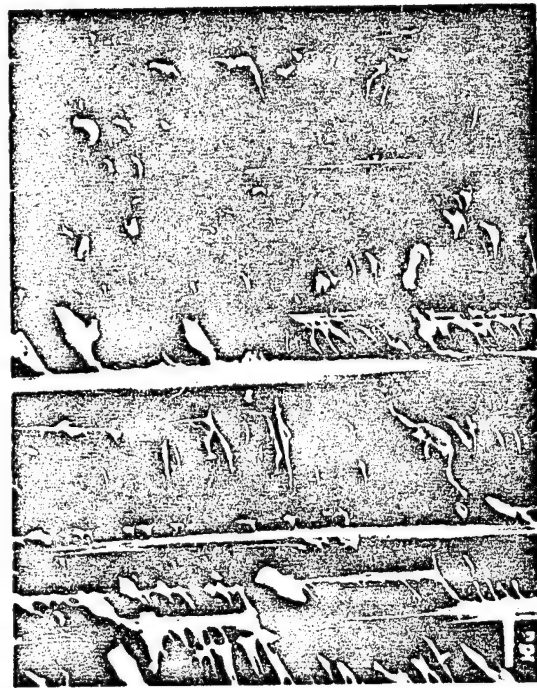
The prominence of intraply shear controlling the fracture process is illustrated in figure 8 which displays the fracture surface of the $[\pm 45]_5$ laminate. The outer plies now consist of an entirely level surface. The distinct characteristic of the intralaminar shear mode is clean fiber surfaces surrounded by matrix hackles which is clearly depicted in the magnification of the outer level plies (fig. 8(c)). Figure 8(b) characterizes the longitudinal tensile fracture mode; however, the pulled-out fibers contain much matrix debris indicating the presence of an intraply shear fracture mode which is the primary cause of fracture for this laminate.

Figure 8. - Photomicrographs depicting the fracture characteristics of the $[\pm 45]_s$ GIE laminate. Intralaminar shear fracture designated by matrix debris and hackles is the primary cause of final fracture.

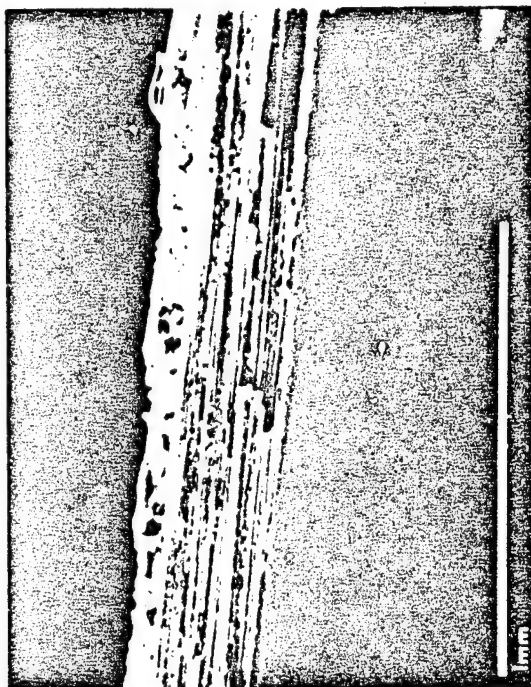
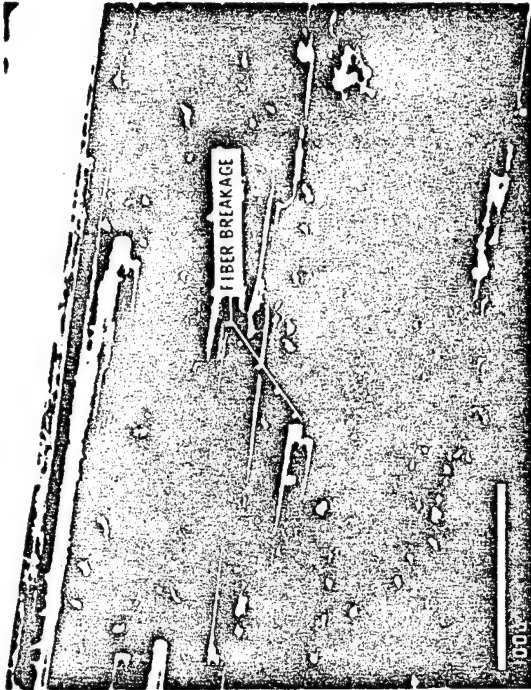
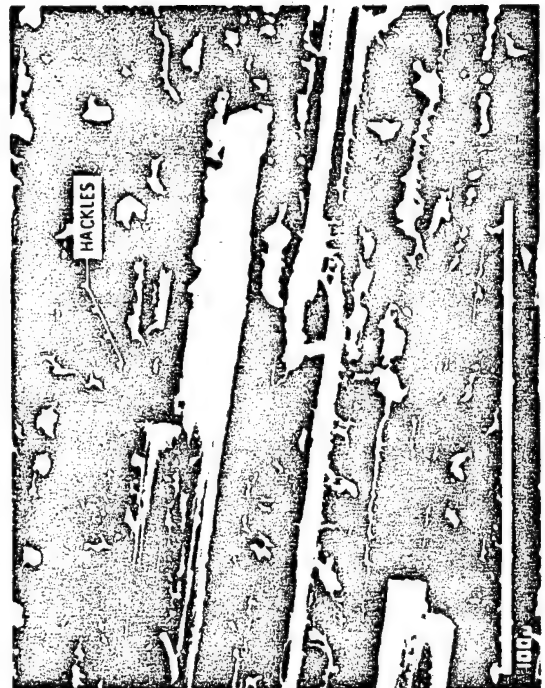
The fracture surface of the $[\pm 60]_5$ G/E laminate in figure 9(a) is entirely flat with no sign of fiber pull-out. Some fiber breakage (fig. 9(b)) did occur but in the transverse direction. These microstructural characteristics are indicative of a transverse tensile fracture mode. The extensive presence of matrix hackles exhibited in figure 9(c) represents the intraply shear fracture mode which also induces final fracture in this laminate.

Figure 9. - Fracture surface characteristics of the [±60] s GIE laminate. The flat surface is indicative of a transverse tensile mode of fracture.

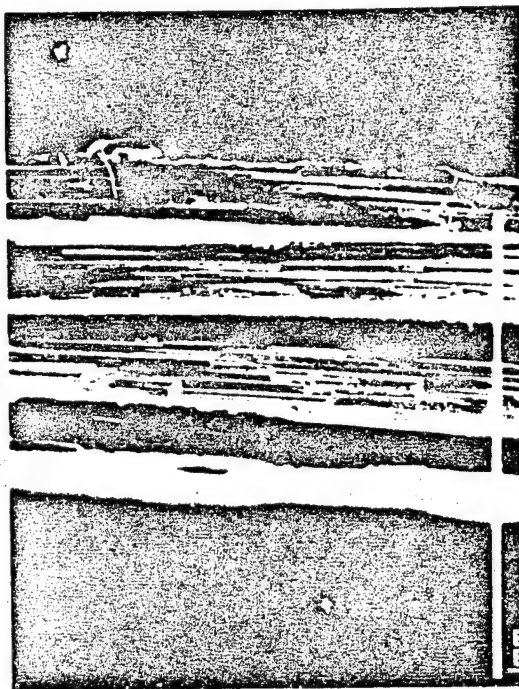
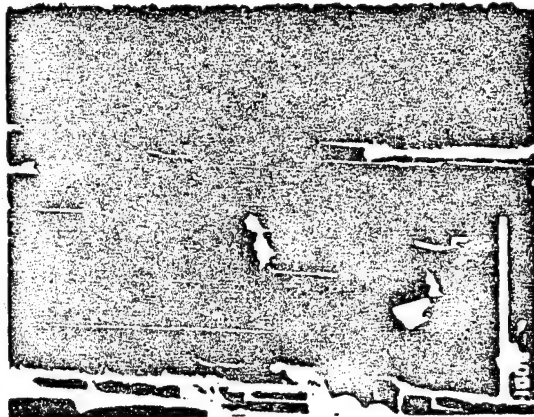
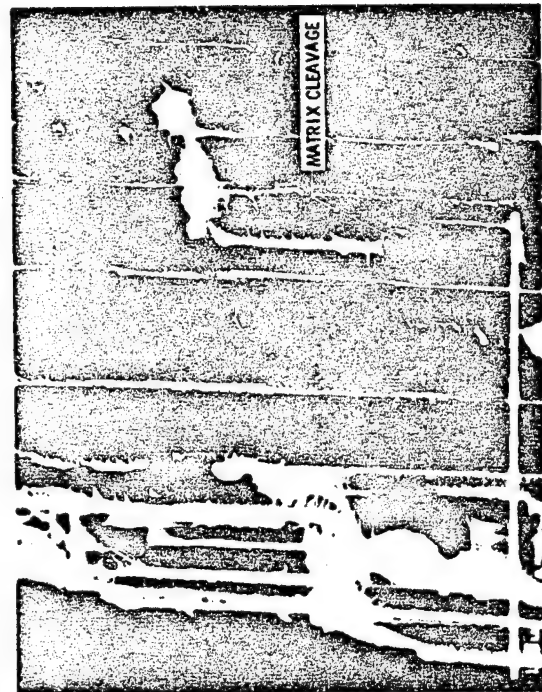
More fiber breakage occurring in the transverse direction on the flat fracture surface of the $[\pm 75]_5$ laminate is shown in figures 10(a) and (b). A new characteristic, matrix cleavage, was observed on this surface and is illustrated in figure 10(c). Matrix cleavage resembles a cutting or hollowing-out of the matrix between relatively clean fibers. The microstructural characteristics of this laminate are the result of a transverse tensile fracture mode.

Figure 10. - In addition to the flat features, the [$\pm 75^\circ$]s G/E fracture surface consists of fiber fracture and matrix cleavage.

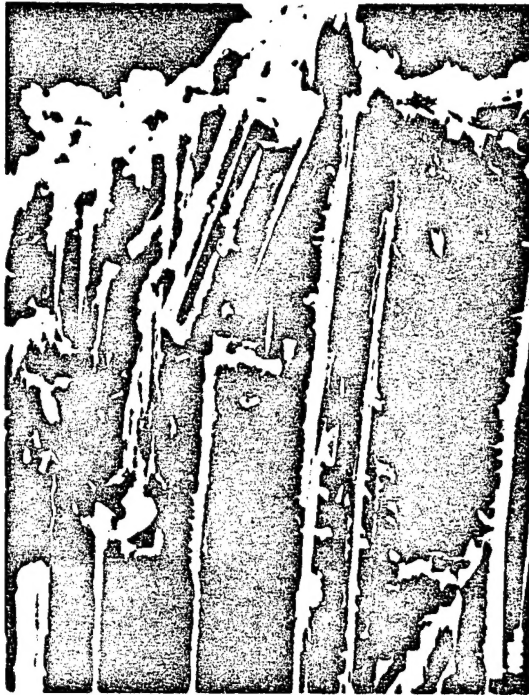
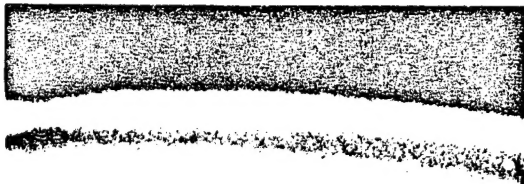
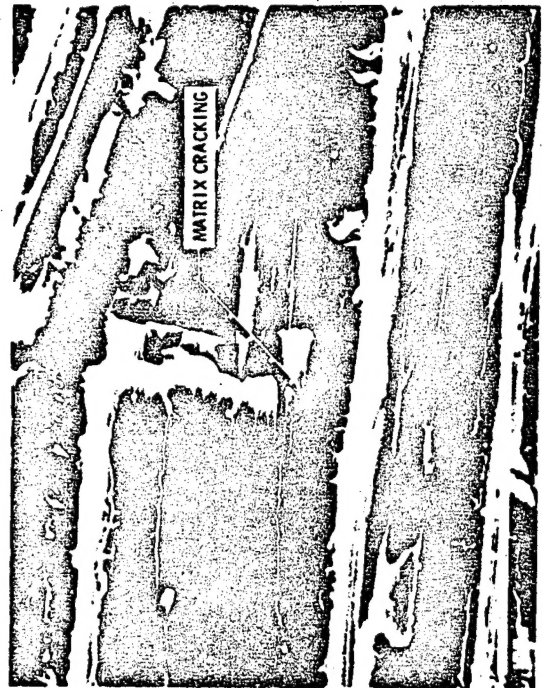
The final fracture surface to be examined is that of the $[90]_4$ G/E laminate presented in figure 11. The flat fracture surface reveals some fiber breakage in figure 11(a). With the occurrence of extensive matrix cracking, the specimen is beginning to fall apart (fig. 11(b)). Magnification of the specimen's edge exposes the matrix cracking and cleavage which causes the fracture due to a transverse tensile fracture mode.

Figure 11. - The fracture surface of the notchless [90]₂ G/E laminate consists of considerable matrix cleavage and cracking.

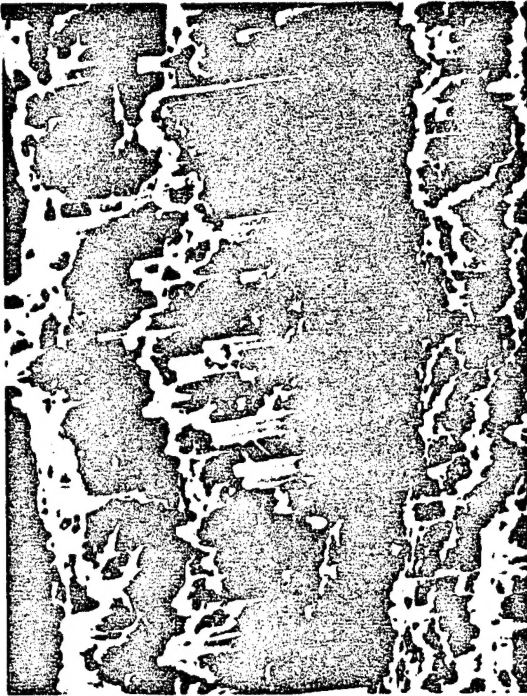
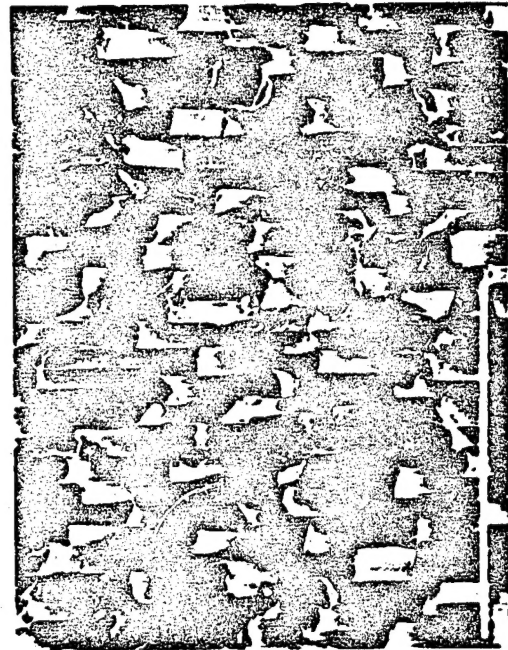
Through the microscopic analysis, it was revealed that neither the presence of a defect nor the type of defect had any affect on the fracture surface microstructural characteristics and thereby the fracture modes. This is illustrated in figure 13 for the unidirectional laminate and in figure 14 for the more complex fracture process of the $[\pm 45]_s$ angleply laminate. As can be seen, the microstructural characteristics are identical for the solid and notched specimens for each laminate. This phenomenon was also present in the CODSTRAN predictions which are listed in table IV. Results for the unidirectional and $[\pm 45]_s$ laminates, as well as all the other laminates, indicate that neither the presence of a defect nor the type of defect affect the primary mode of fracture in these G/E $[\pm \theta]_s$ laminates. Therefore, use of the fracture surface of the notch/slit laminate to represent the microstructural characteristics of a particular laminate is valid.

Figure 13. - The microstructural fracture surface characteristics of the unidirectional G/E laminate.

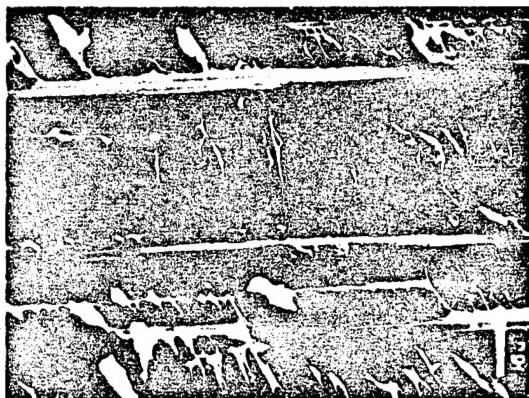
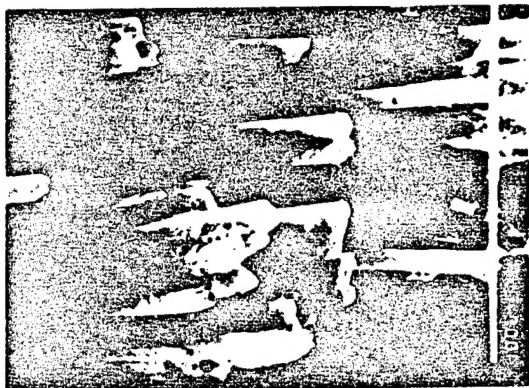
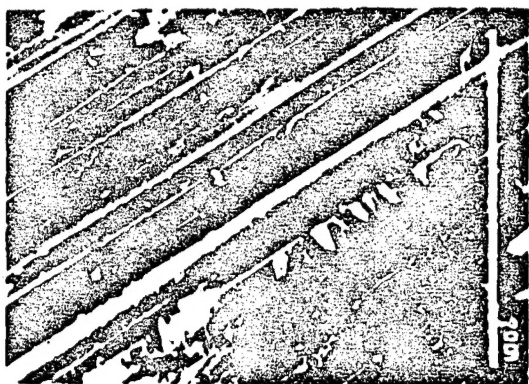
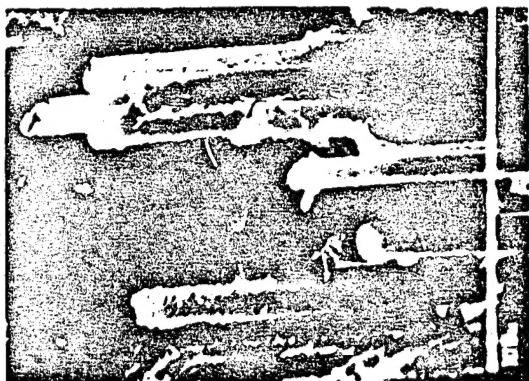
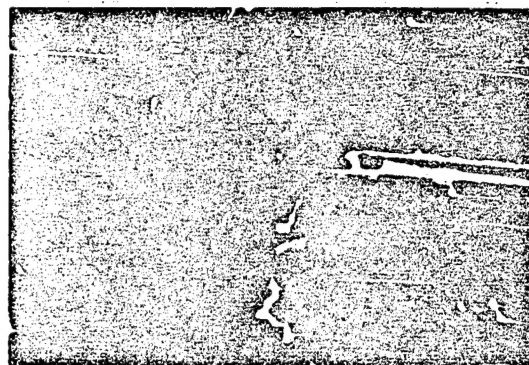
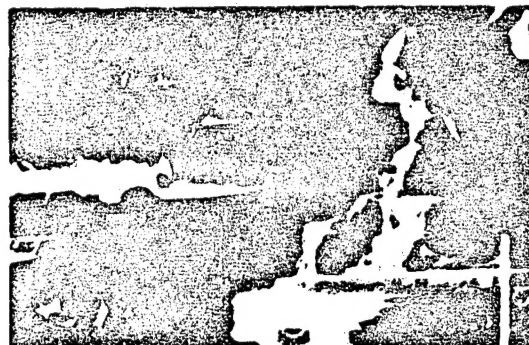
Figure 14. - Fracture surface characteristics of the ϵ_2 45° G/E laminate.
